The DR-2 project

Ølgaard, Povl Lebeck

**Risø National Laboratory, Roskilde, Denmark
June 2003**

DR-2 was a 5 MW tank type, water moderated and cooled research reactor, which was operated at the Risø National Laboratory from 1959 to 1975. After the close-down in 1975 the DR-2 has been kept in safe enclosure until now. The aim of the DR-2 project reported here was to characterize the present state of the reactor and to determine, which radionuclides remain where in the reactor in what amounts.

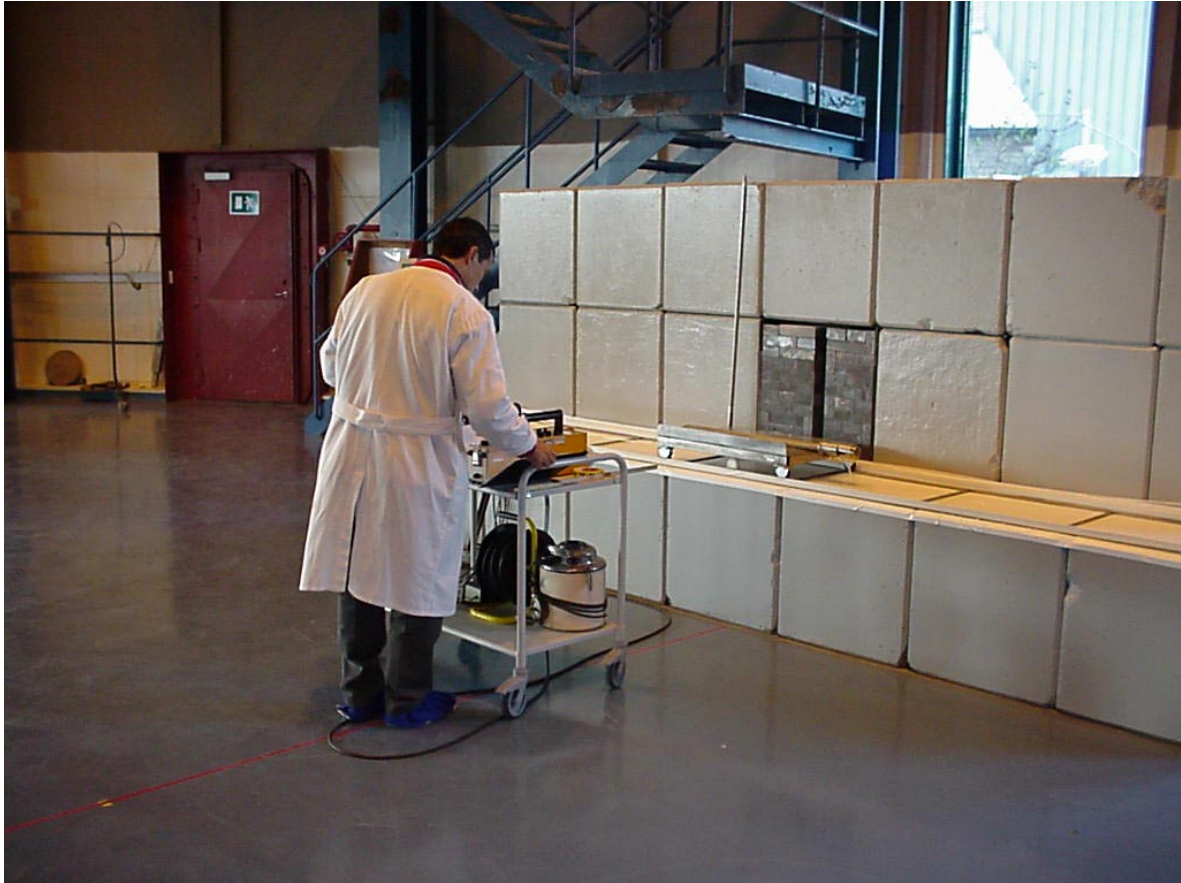
Figure A12. γ -spectrum measurement of a shim-safety rod at the measurement facility.

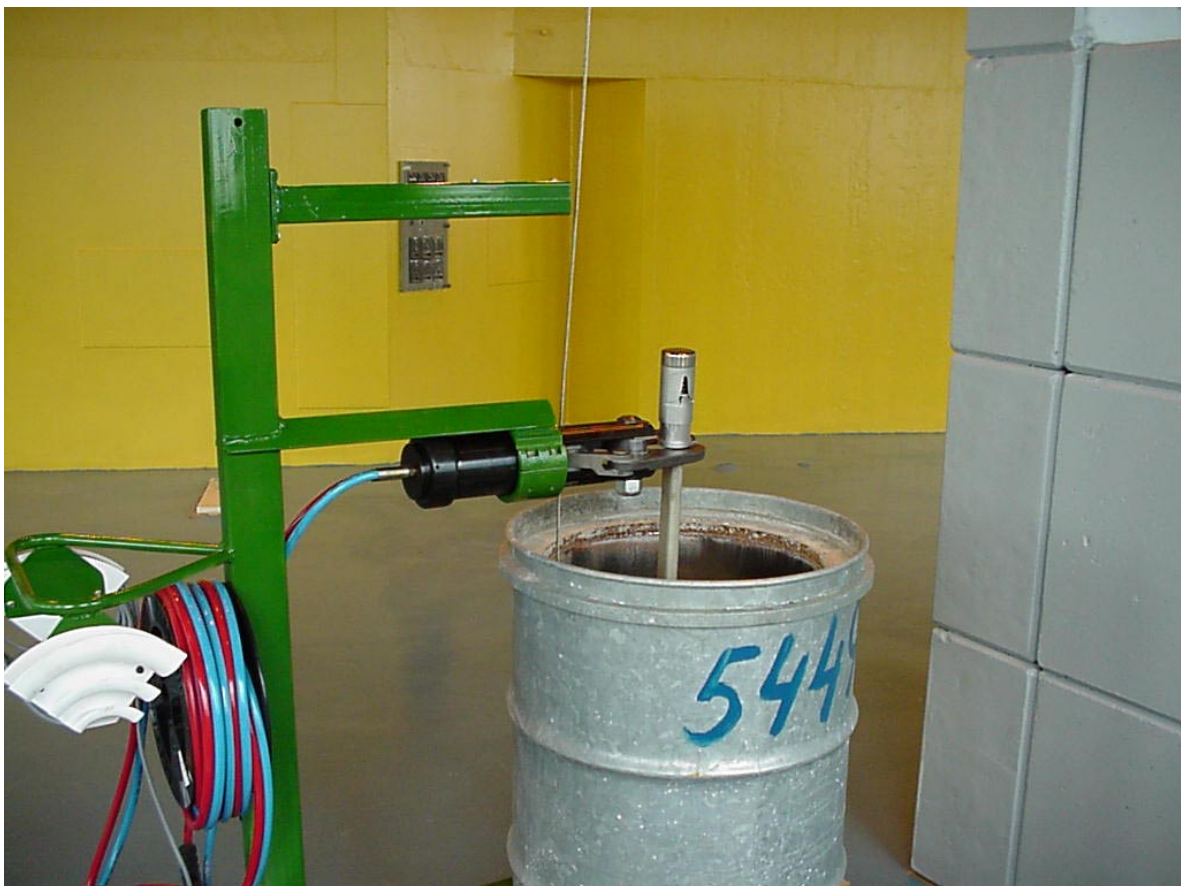
Figure A13. Cutting the armature and shock absorber off a shim-safety rod.

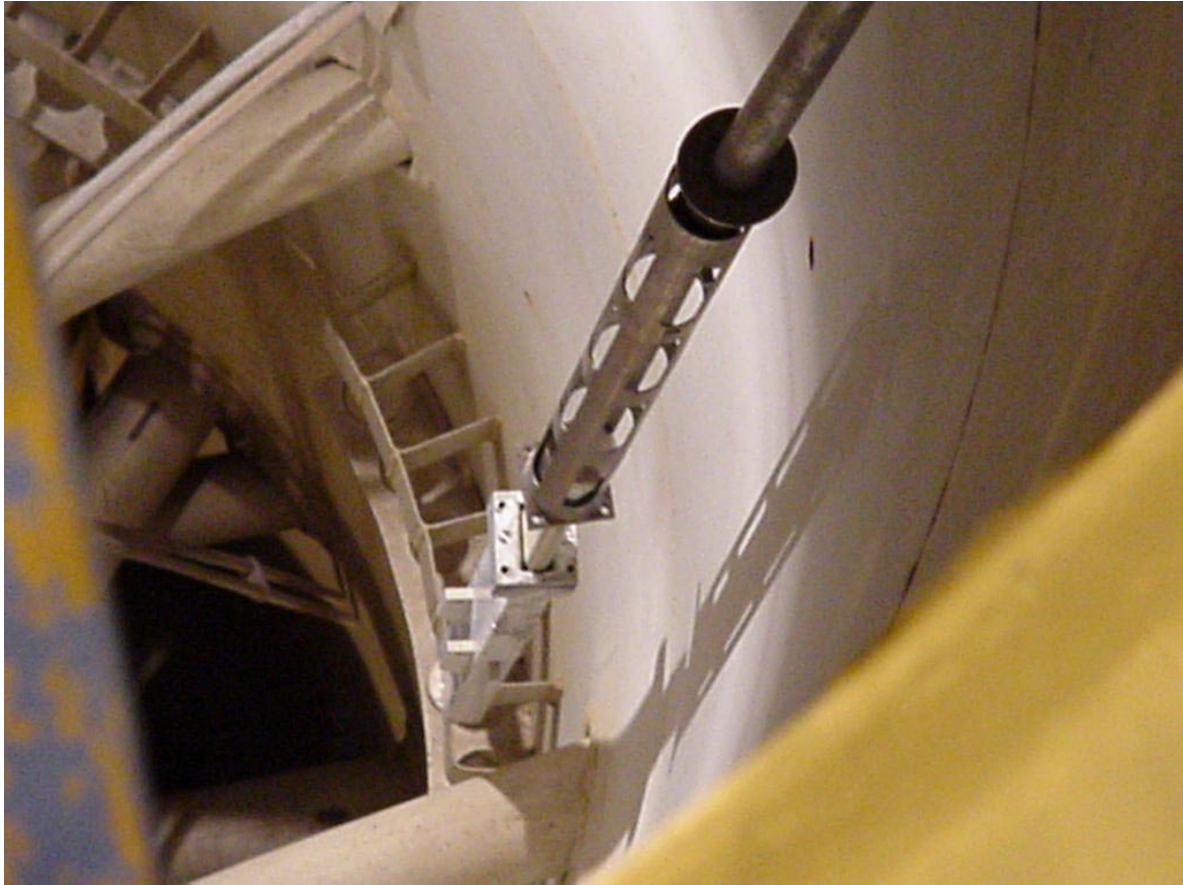
Figure A14. Calibration tool with stuck shim-safety rod and guide tube. Magnet rod on top.
